Urban Design Study for Knocktopher

Overview

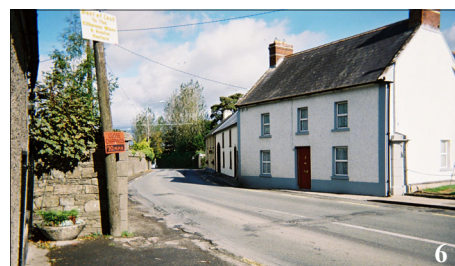
Photo 6: View northwards towards Post Office from in front of the Catholic Church - note the sharply deflected building line which gives great interest to the streetscape.

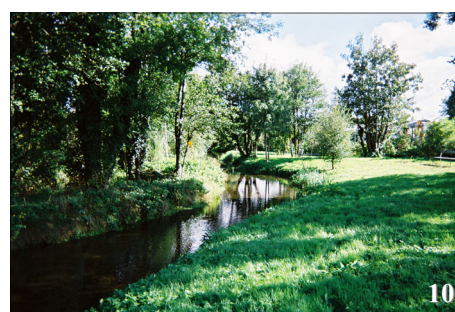
There are just two areas of public open space in the village. The principal area is the 'active' space in the form of the playing fields, immediately south and east of the Catholic Church. The second area comprises 'passive' open space, in the form of a landscaped wedge of land that adjoins the stream. While it is accessible to the pedestrian, there is only one car parking space serving this small park. Picnic benches/seating is also provided.

Photo 10: Riverside park.

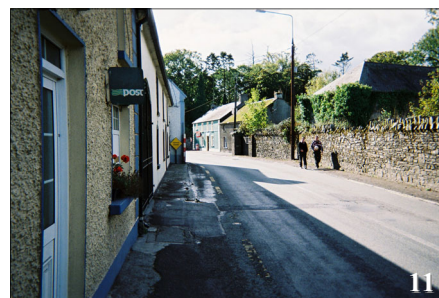
Photo 11: Deflected street adds interest to the streetscape, but with heavy traffic on the busy N9, safety is a concern. The lack of a footpath on the left side reduces pedestrian comfort level

Consideration should be given to traffic calming measures on either side of the National Primary road and within speed limit areas. This would reduce carriageway width but would force traffic to move at slower speeds. A sign on the east side of the southern approach to the school, relating to school safety, is poorly maintained and overgrown with hedgerow vegetation.

- Provide and/or reinstate a footpath on the east side of the road in front of the Post Office and the adjoining terrace.
- Ensure that any new infill development respects traditional building lines in the vicinity. New infill developments will be expected to have regard for the Design Guidelines on Future Development (Appendix A).

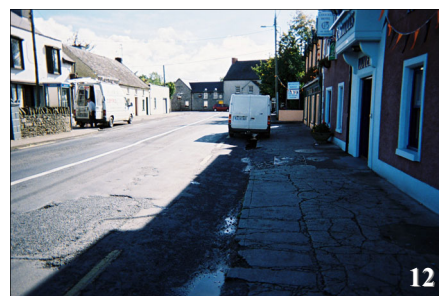
Photo 12: Quality of footpath in centre of village is in poor condition.

While road surfaces are generally good throughout the village, the road edges (adjoining footpaths and verges) are in poor condition at a number of locations, notably, between service station and Callan Road on the west side; and opposite the Post Office, between the graveyard and the short terrace further south.

- Improve the footpath on the west side of the road between the former Carmelite Convent/graveyard at Cnoc an Tóchair and the terraced group of buildings further south (see Urban Design Map).

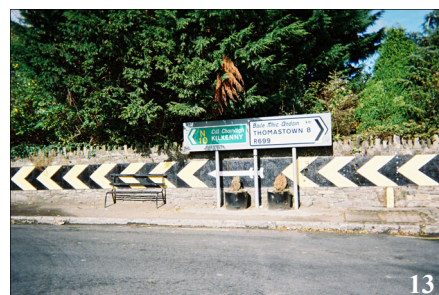
Photo 13: Street furniture—planters and seat—are in relatively poor condition.

The village displays at least three different types of planters, some of which are poorly maintained. Uniformity in the design of these planters would add to the streetscape.

There is only one street bench (seating) in the village (near the junction between Thomastown Road and the N9 - though functional and south facing, it does not provide much character.

- Ensure the uniformity of planters and replace where appropriate.
- Maintain the landscaped area immediately before the speed limits on the Callan Road (south side).

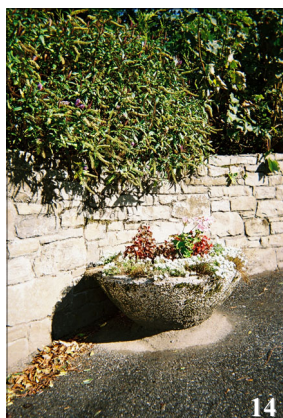
Photo 14: One of a variety of planters to be found in the village.

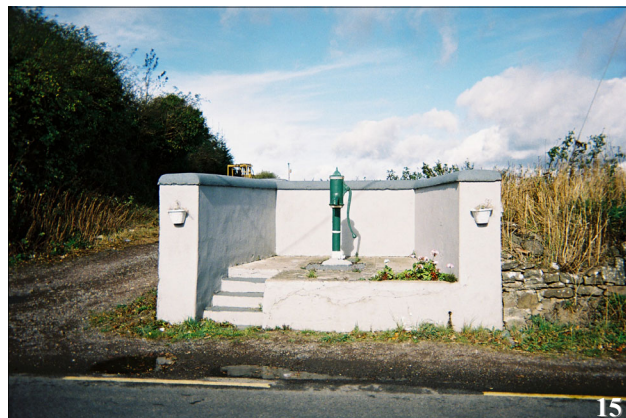
Photo 15: Traditional Water pump is an attractive historic feature in the village and should be maintained.

The old water pump near the Graigenamanagh Road/N9 junction should be maintained, as this traditional feature adds character to the area.

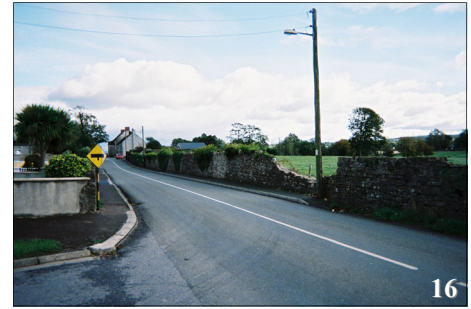
Photo 16: Stone wall on the Callan Road requiring repair.

- Protect the important tree groups identified on the Urban Design Map.
- Protect, reinstate and/or repair the old stone wall in areas identified allowing for necessary access where appropriate.

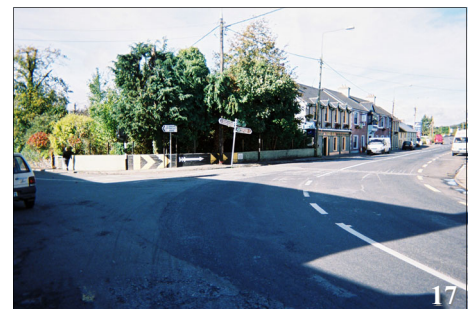
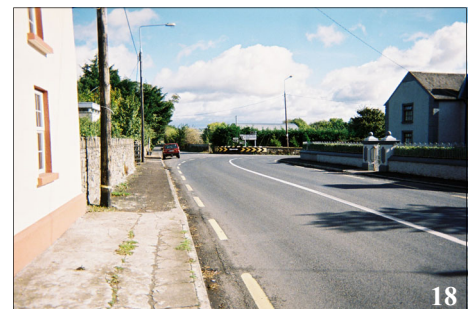
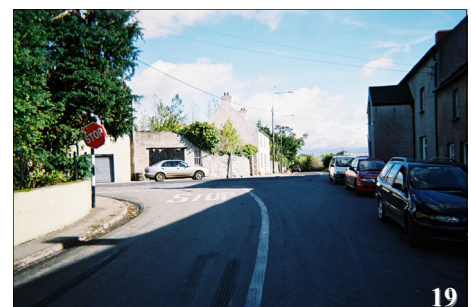
Photos 17, 18 & 19: Examples of strategic sites at road junctions, which act as important focal points when passing through the village - important yet sensitive architectural treatment required. Their current state does little to enhance the image of the village.

- Incorporate the northernmost stream as a linear park.
- Ensure the continuation of building lines and specifically encourage good quality architectural designs on all focal sites identified on the Urban Design Map.
